WYLE LABS HUNTSVILLE ALA  
CAPSIZING/SWAMPING ACCIDENT INVESTIGATIONS FOR 1976 SEASON. (U)  
SEP 77 J BOWMAN, B SMITH

CAPSIZING/SWAMPING ACCIDENT INVESTIGATIONS FOR 1976 SEASON

16. Abstract From several hundred boating accidents, 28 were selected for in-depth investigations. These in-depth investigations were performed to augment and supplement the Coast Guard's data base acquired from the nationwide Boating Accident Reports (BARs). Unlike the several thousand BARs received annually, the in-depths contain details of the entire accident scenario and are used to assist in establishing national programs of loading related accident prevention by boat design and education.  This report summarizes the criteria for selection of those accidents to be investigated, the investigation procedures, and the accident data obtained for the 28 in-depth investigations. Each individual accident report is presented as Appendices to the summary report. The accident reports present information concerning the weather, the involved boat and occupants, causal factors, boat capacities and loading/powering information, and occupant actions/reactions prior to, during, and after the actual accident event.

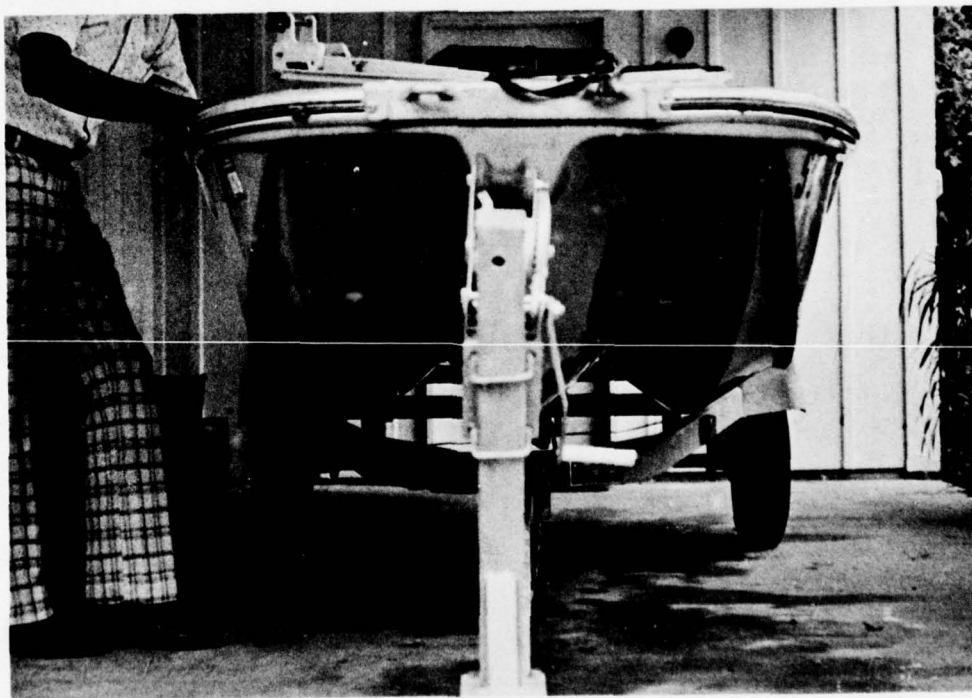
Refer to Figures 4, 5, and 6 for overall boat views, and Figure 7 for transom and motor view.

FIGURE 4. INVOLVED BOAT

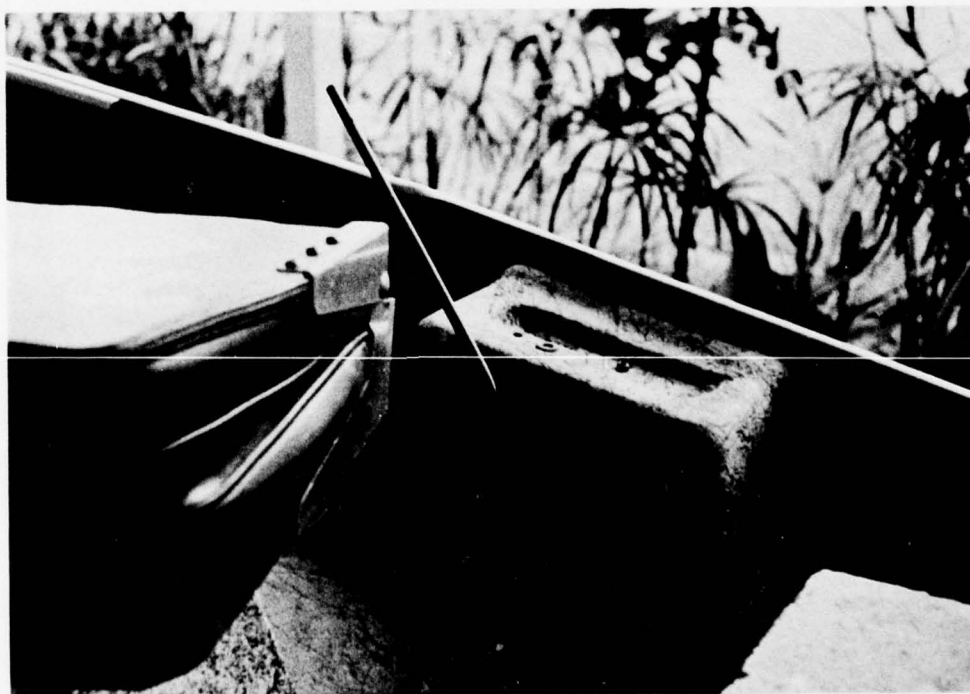
turn. The control stick was bent aft which would strongly indicate that the stick went forward and hit the deck with enough force to cause the bend. It is very unlikely that the operator could have exerted sufficient rearward force on the steering stick to cause the deformation. This is considered a likely factor in causing this accident. Refer to Figure 8 for deformed steering stick and Figure 9 for plastic ball location.

FIGURE 8. DEFORMED STEERING STICK

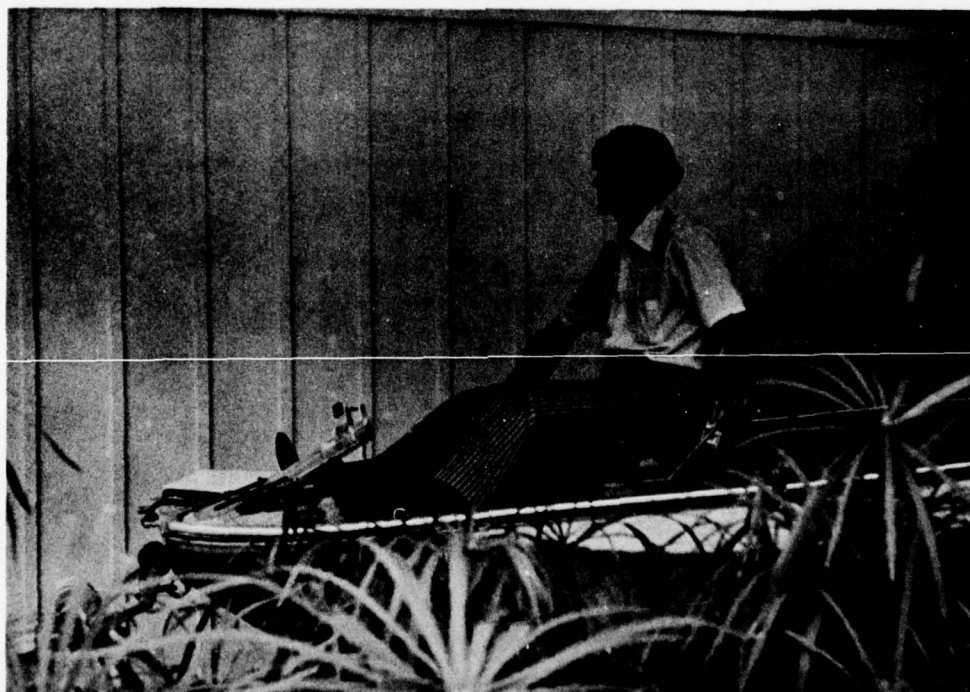
The boat entered a hard turn to starboard and, due to the hull design, began to skid to the outside of the turn. As the turn continued, the skidding action caused the keel to ride up over the bow wake. The boat then rolled to port (tripped), and the port chine dug in, causing the skidding motion to abruptly stop. Sufficient momentum had been generated in the turn, so that when the lateral motion of the boat was stopped, the momentum of the occupants caused them to be thrown out of the boat on the port side. The operator stated that he always kept his hand on the throttle when traveling full speed. Seated in the normal operating position (see Figure 10), the normal reaction of the operator would be to hold to the throttle for support when being thrown over the port side. The throttle position for full speed is down and forward; therefore, if the operator held to the throttle, the force exerted would cause the lever to come up and aft, reducing the engine rpm. This would account for the slower speed the boat was traveling after the occupants were thrown overboard. Figure 10 shows the stick steering position for zero motor angle after the accident. Figure 11 shows the approximate normal zero motor angle position prior to the accident.

FIGURE 10. STICK STEERING POSITION FOR ZERO MOTOR ANGLE AFTER ACCIDENT

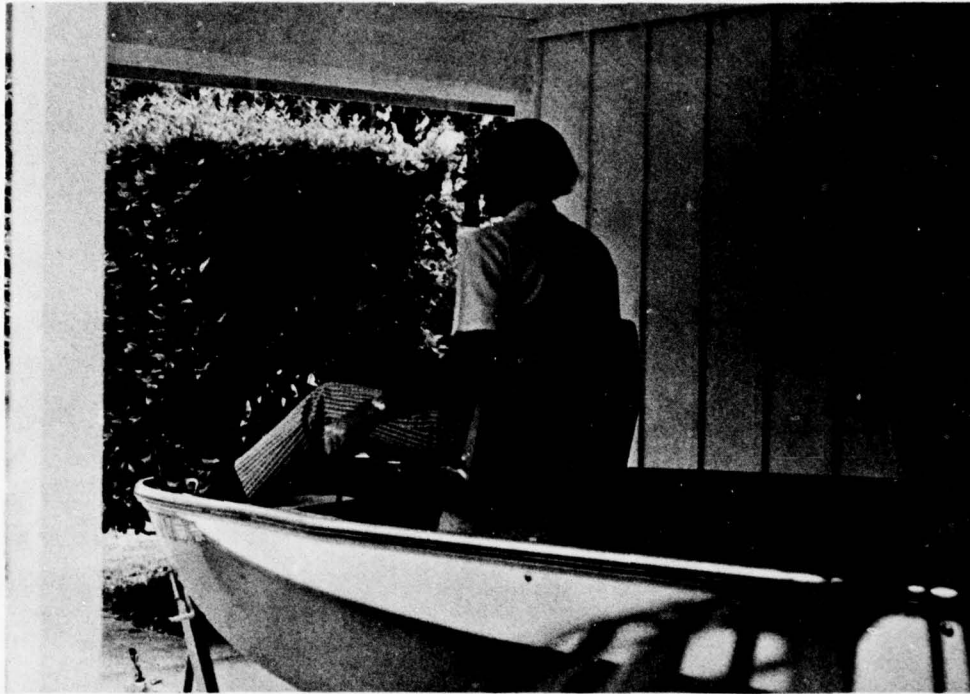
FIGURE 11. APPROXIMATE NORMAL ZERO MOTOR ANGLE PRIOR TO ACCIDENT

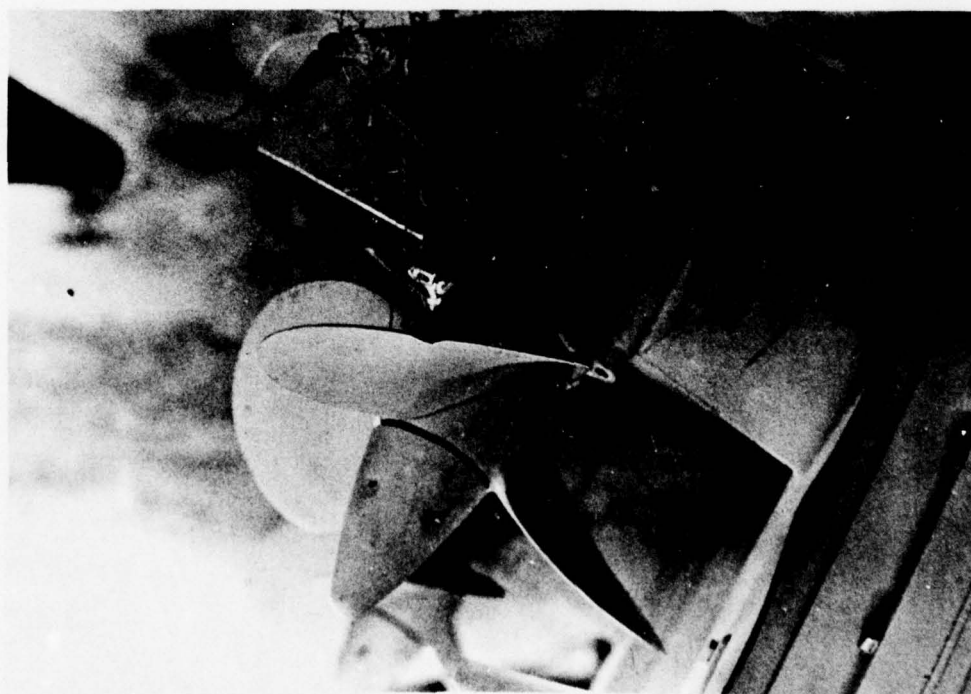
FIGURE 7. PORT ENGINE. NOTE FISHING LINE IN PROPELLER

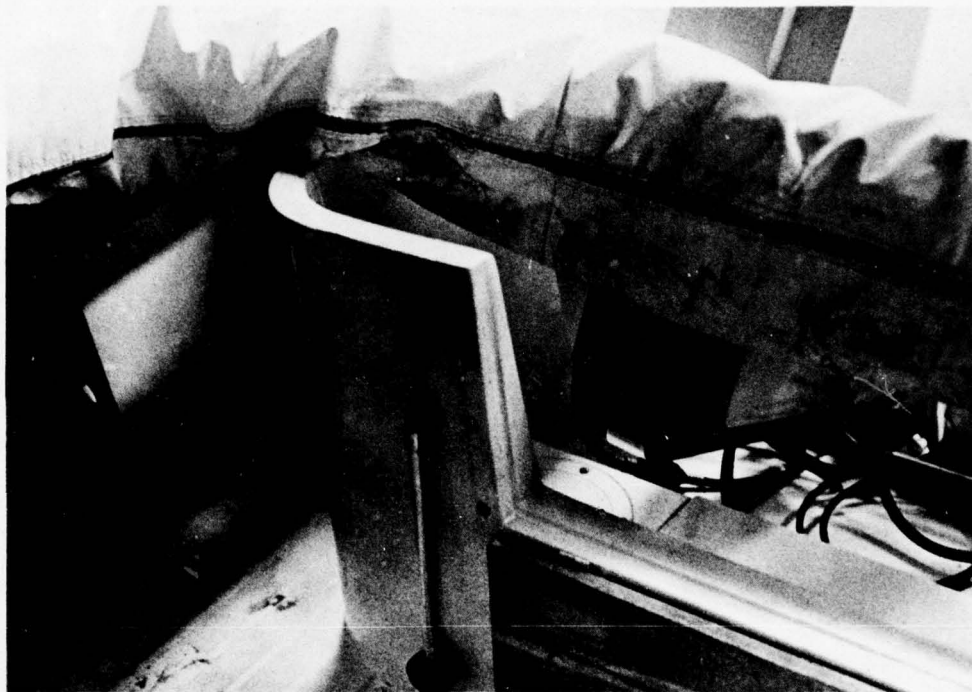
FIGURE 8. NOTE FOLDED DOWN MOTORWELL BULKHEAD

The boat's load of persons, motor, and gear was well below its capacity plate limitation. There is some possibility, however, that enough water was shipped over the transom (and hence into the bilge, because the owner modified the motorwell such that any benefit it may have provided was cancelled) to make the boat more prone to being swamped. This effect would have depended on the extent to which the electric bilge pump was used, which was not able to be clearly determined.

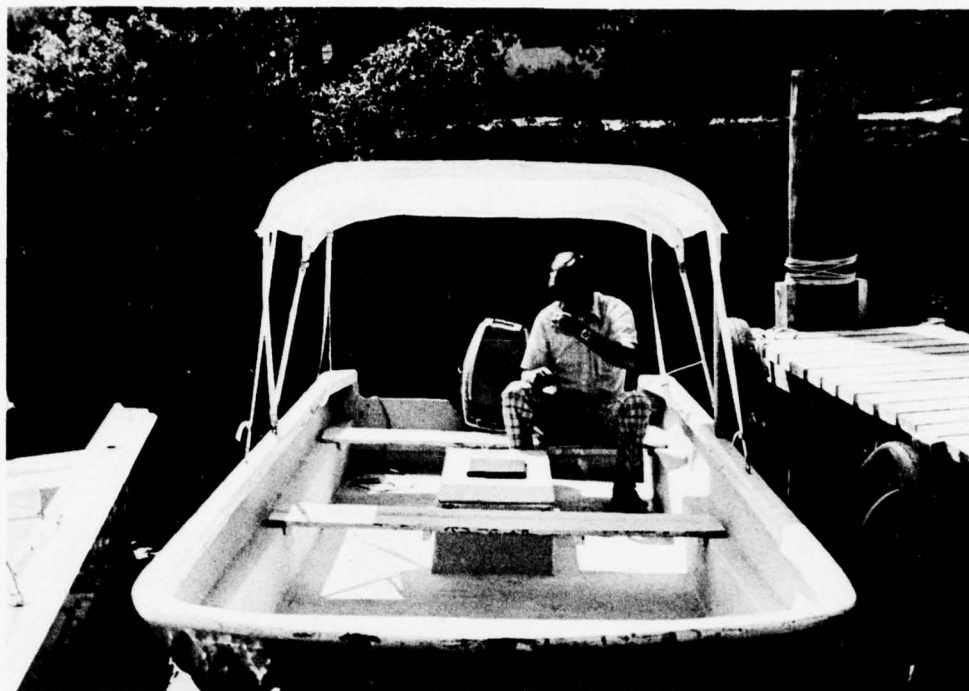
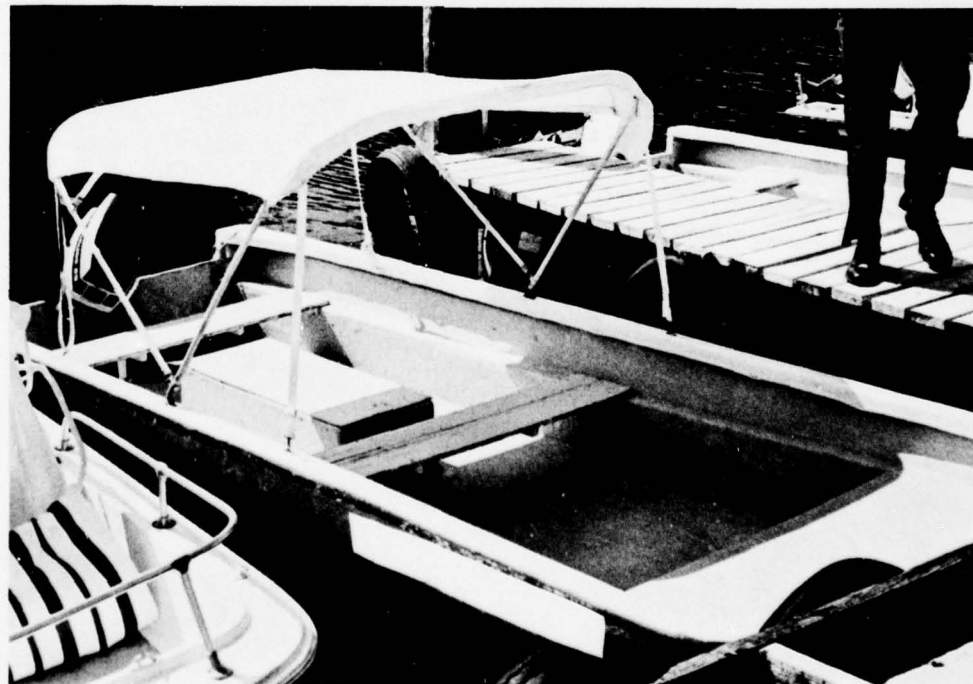
The boat appeared to be in very good condition and no evidence of damage resulting from the accident could be found. Refer to Figure 3-6 for overall boat views.

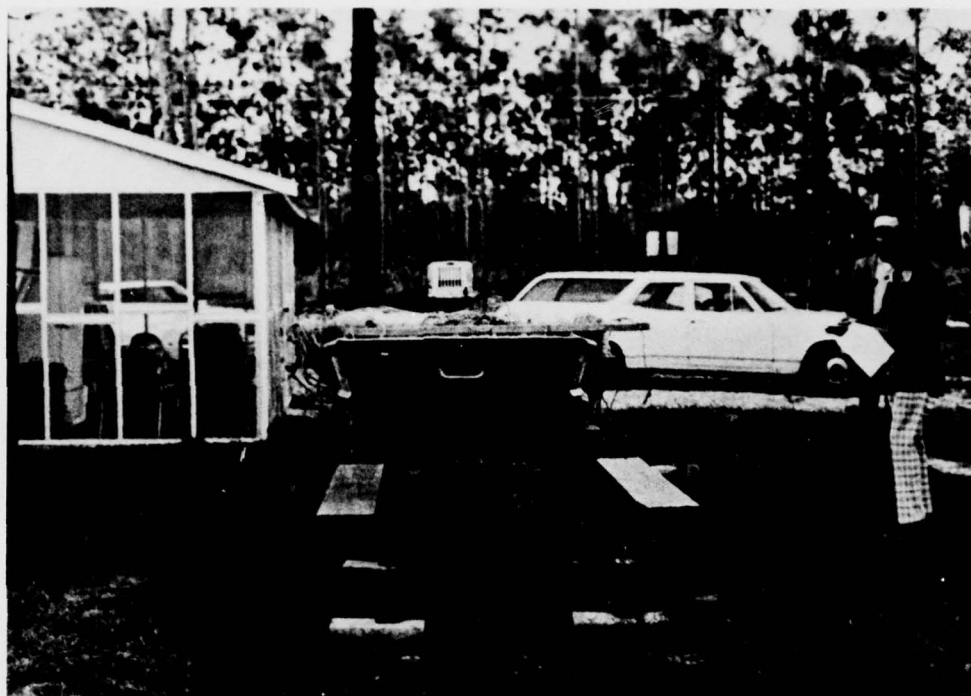
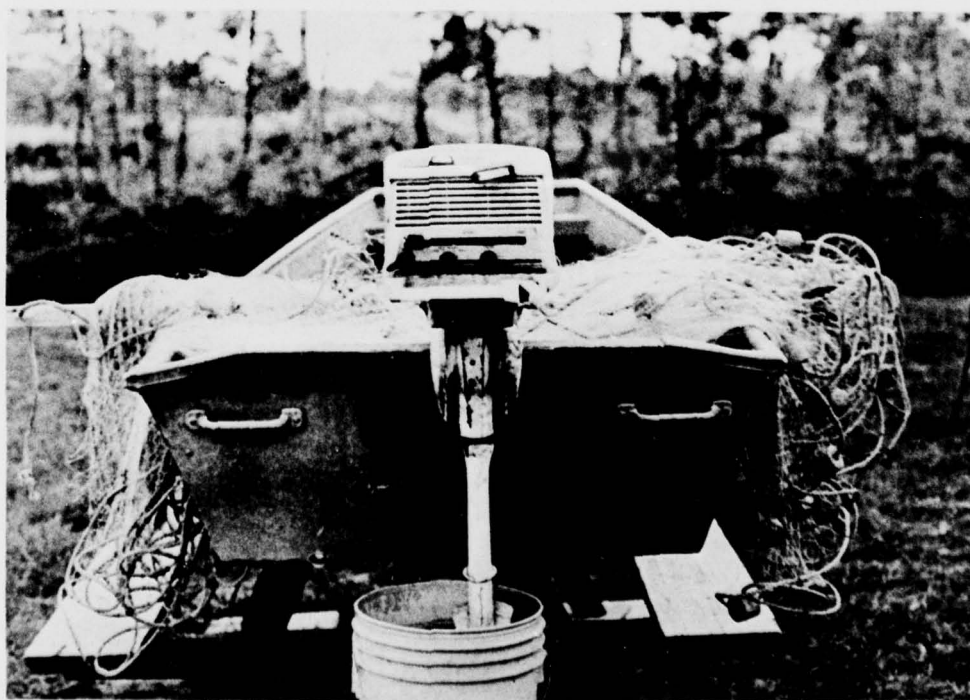
No evidence of damage as a result of the accident could be found. Refer to Figures 3-5 for overall boat views.

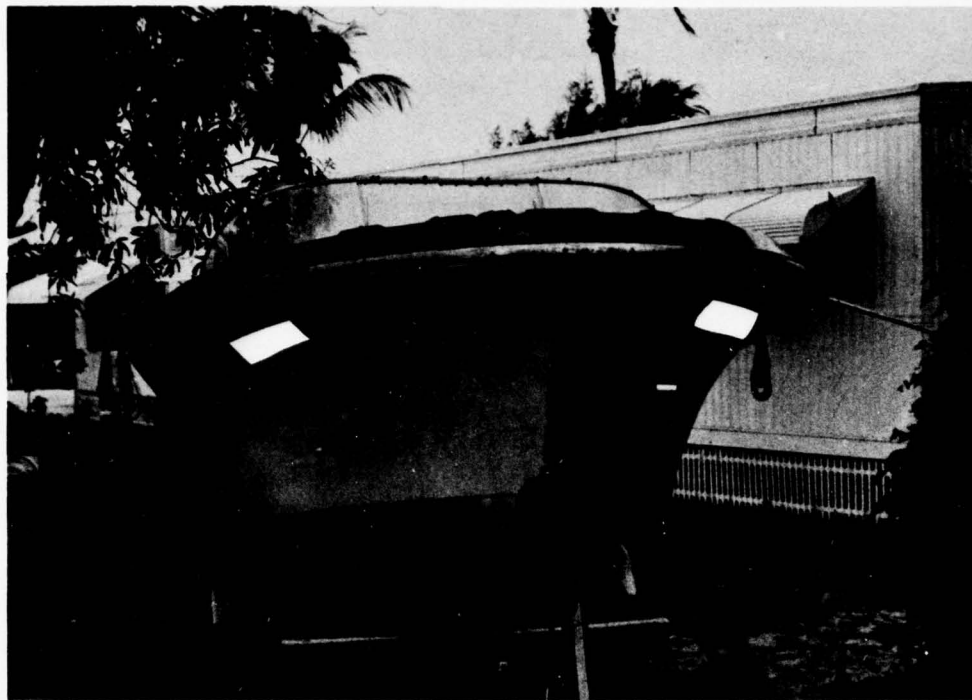
FIGURE 3. BOW VIEW

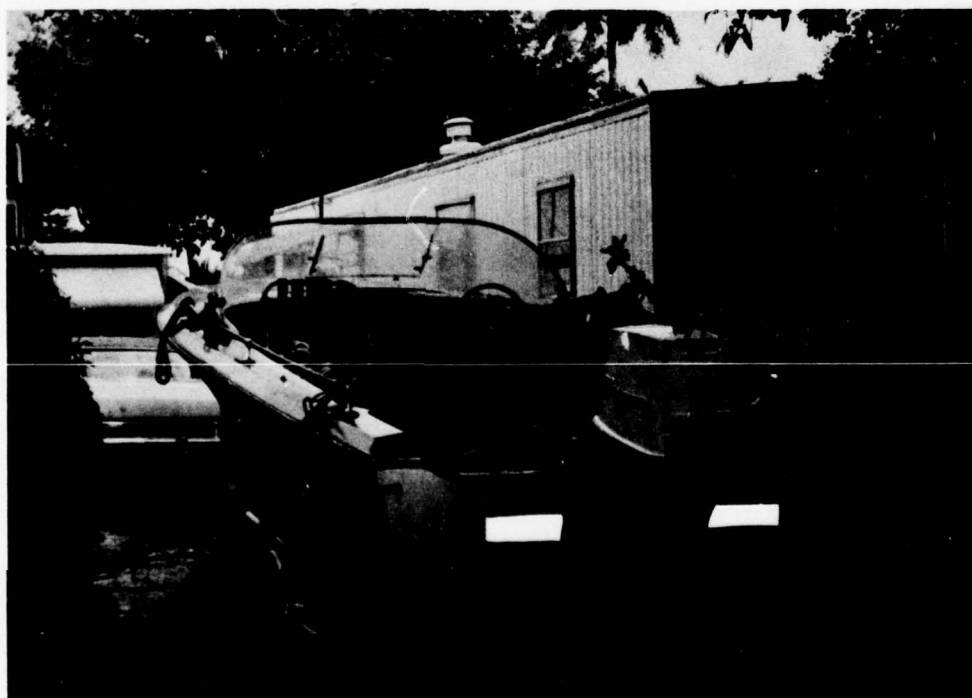
FIGURE 4. STERN VIEW

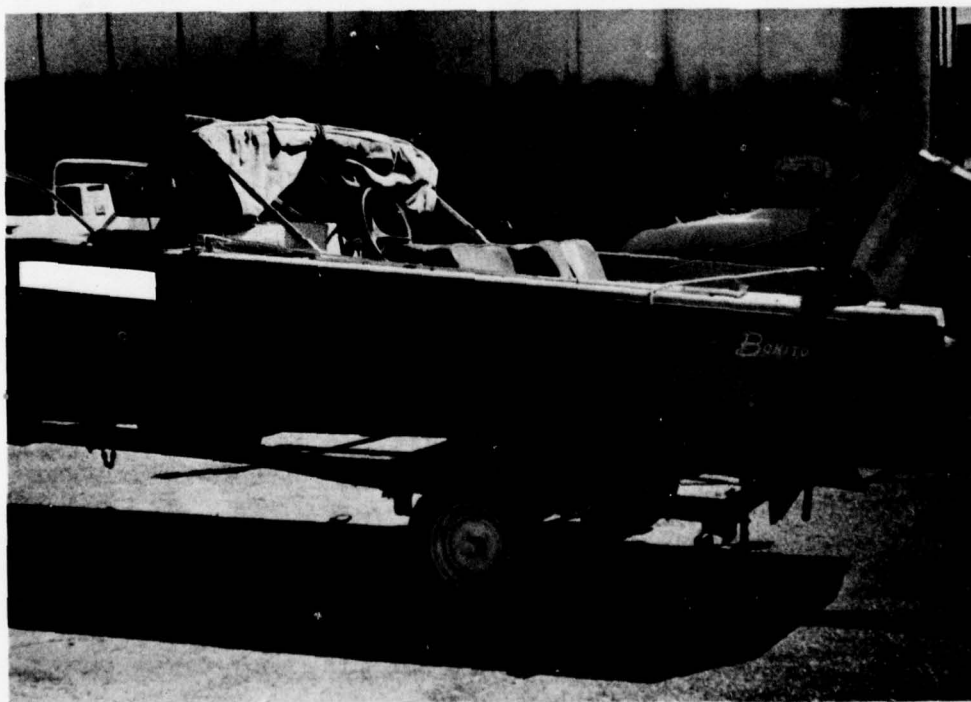
FIGURE 4. SIDE VIEW

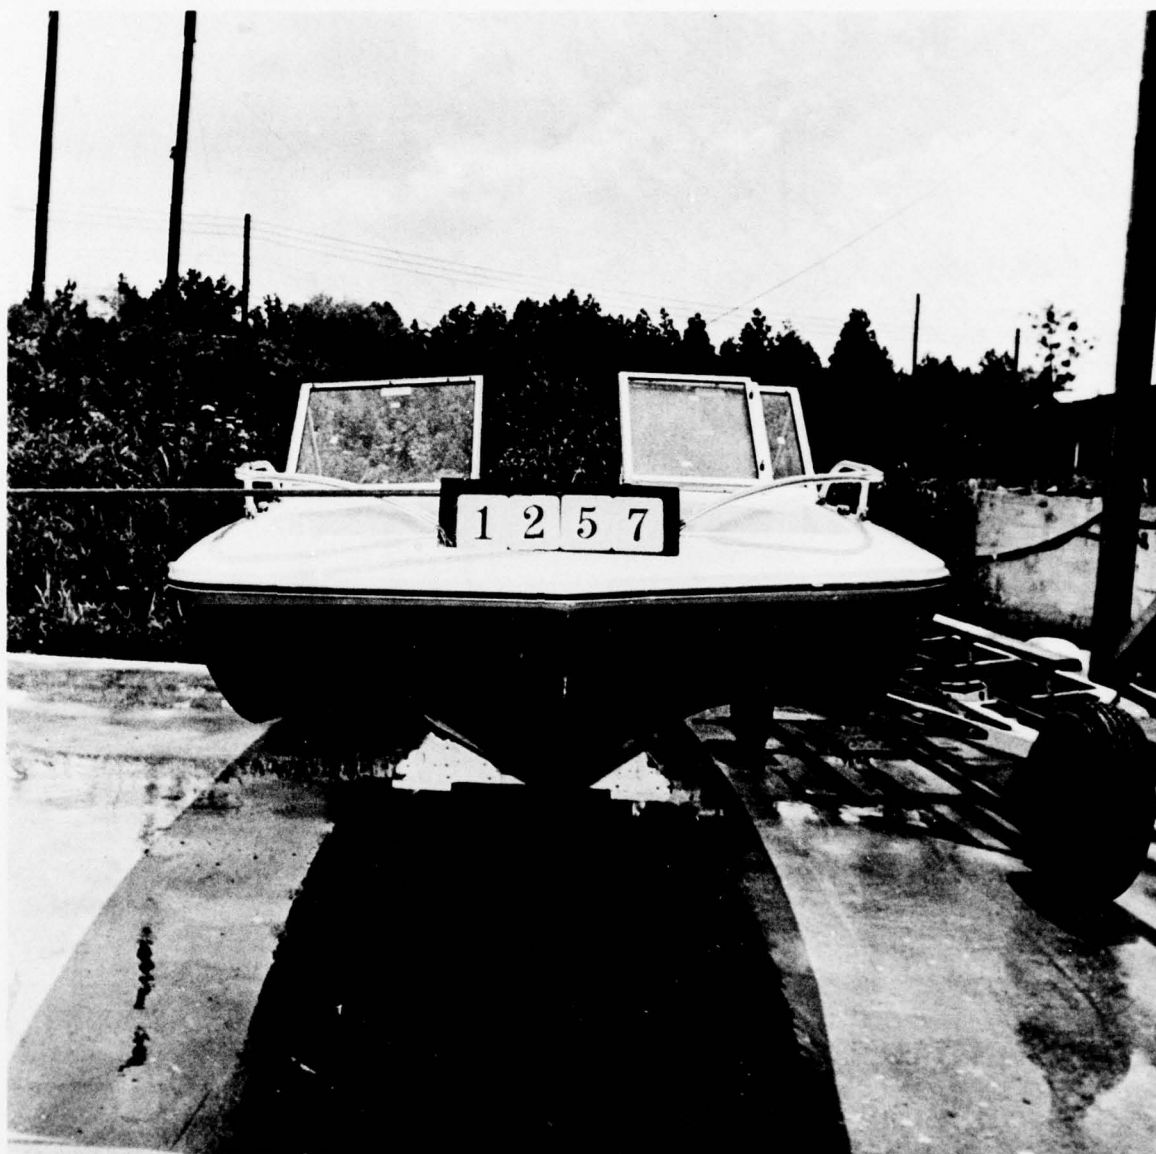
FIGURE 3. BOW VIEW
